Public Service Company of Colorado (PSCo), an Xcel Energy company, owns and operates under a license issued by the Federal Energy Regulatory Commission (FERC) the Cabin Creek Pumped Storage Hydroelectric Project (FERC No. 2351). As part of the relicensing studies, HDR conducted a functional assessment of all ecologically significant riparian and wetland areas to determine the condition of site wetland functions and characteristics. The Project is located within the Arapaho National Forest and occupies a total of 268 acres of National Forest lands. The site is located on South Clear Creek and its tributary, Cabin Creek, in Clear Creek County, Colorado, USA.

# Functionality of Alpine Wetland Habitats Using the Functional Assessment of Colorado Wetlands Method (FACWet) at a Pumped Storage Hydroelectric Facility in the Rocky Mountains of Colorado

Erin Page, HDR Engineering - Bellingham, Washington

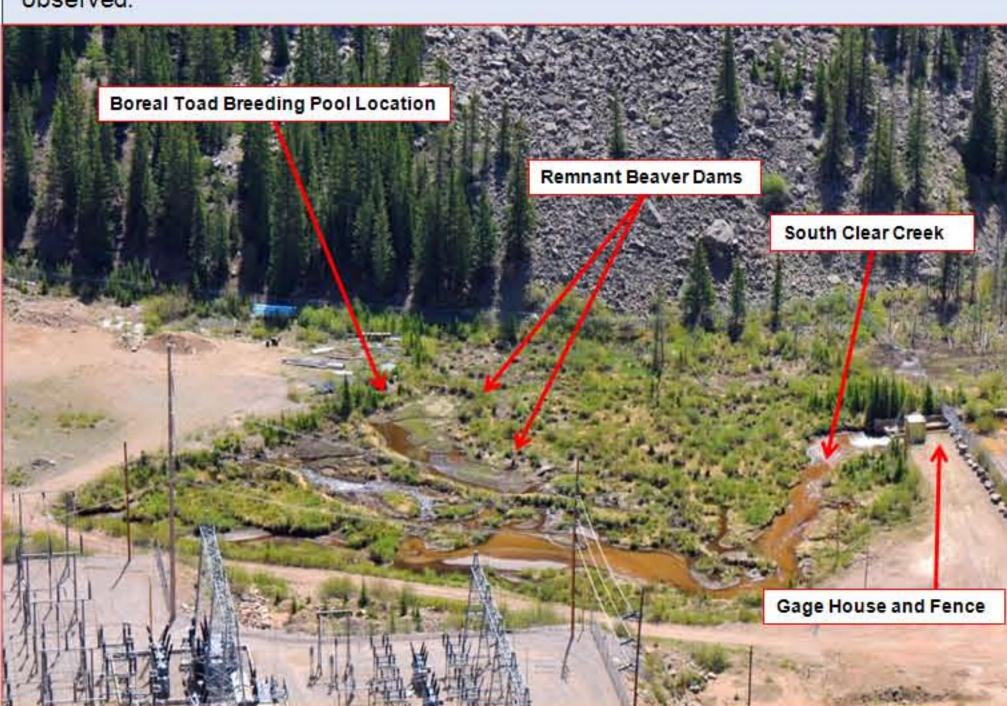
Figure 1. Overlook of Wetland Site 4 and the Boreal Toad Breeding Pool.

During FACWet assessment of Site 4 in July 2010, more than 1,000 boreal toad (Anaxyrus [formerly Bufo] boreas boreas) larvae were observed in a depression that was approximately 2 m wide x 10 m long, with a maximum approximate depth of 3.8 cm (Figure 1).

Changes to Site 4 were documented in 2011. High spring runoff caused downcutting erosion and loss of woody debris at the outlet of the site damaged vulnerable, remnant beaver dams (Figures 1, 2 and 4).

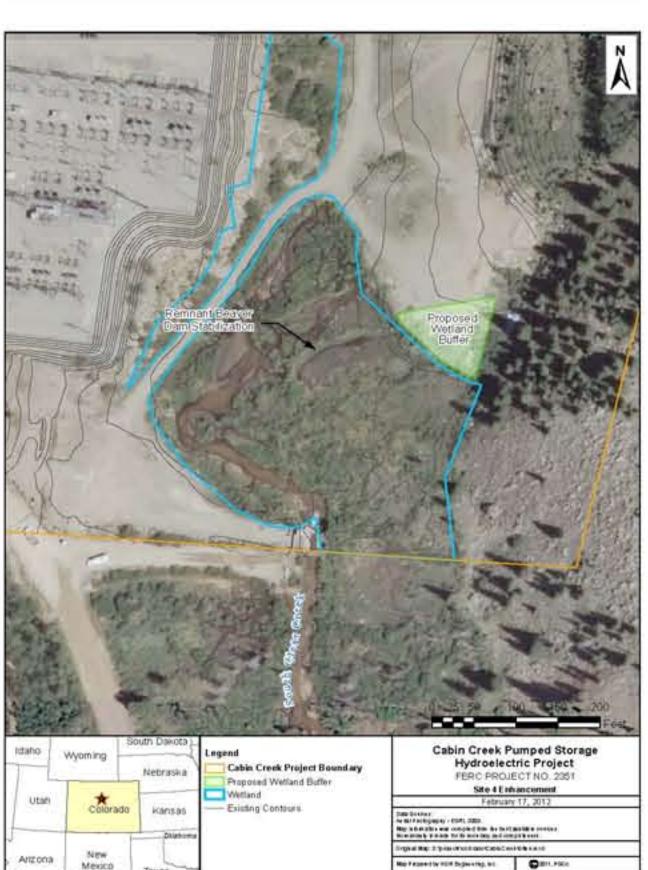
Figure 3. Aerial View of Site 4 Conceptual Enhancements

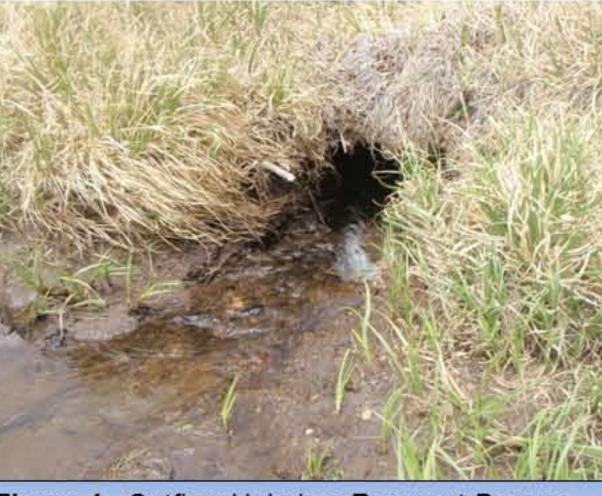
Figure 4. Outflow Hole in a Remnant Beaver
Dam Potentially Created by a Surge Flow Event

In 2011, boreal toad eggs did not survive to hatching because of an unusual flood event that swept away the eggs and damaged the remnant dam at the outlet, a porous breach which had provided a suitable hydraulic control for water level. Damage to the outlet created a hole in the remnant beaver dam, lowered the hydraulic control point, and reduced the maximum area and depth of the impoundment to the extent that the habitat is likely prone to early drying (Figure 3 and 4). Despite less suitable conditions, the site may still attract breeding boreal toads, which like other pond-breeding amphibians tend to exhibit high fidelity to breeding sites.

To restore suitable boreal toad breeding and rearing conditions, PSCo and HDR are repairing the remnant beaver dam that shelters the breeding pool from damaging flows and aquatic predators. Currently, a stop-gap repair will consist of patching the hole in the remnant beaver dam and reinforcing the immediately adjacent structure (Figure 5). The dam patch will be comprised of suitably sized woody debris collected from the trash rack, sandbags and stockpiled soil from within the Project Boundary. PSCo will also evaluate the overflow spill outlet, and will design the repaired dam to hold water in the pool, optimizing the size/depth of the pool for breeding. Without repair of the remnant beaver dam, it is likely that Site 4 will be lost as boreal toad breeding habitat, the remnant beaver dam will continue to deteriorate, and other functional values of the wetland will degrade. Although no measure can guarantee successful boreal toad breeding and rearing, PSCo anticipates that this stop-gap measure will be sufficient to permit boreal toad breeding in 2012 and maintain the population until a more robust enhancement is implemented.

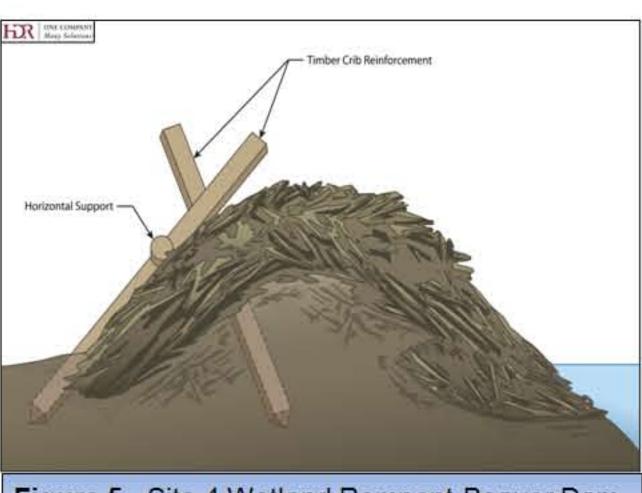
Figure 5. Site 4 Wetland Remnant Beaver Dam Conceptual Stabilization.
