Application of Living Shoreline Stabilization Methods to Protect Shell Middens in Mosquito Lagoon, FL

Melinda Donnelly
Linda Walters
Paul Sacks

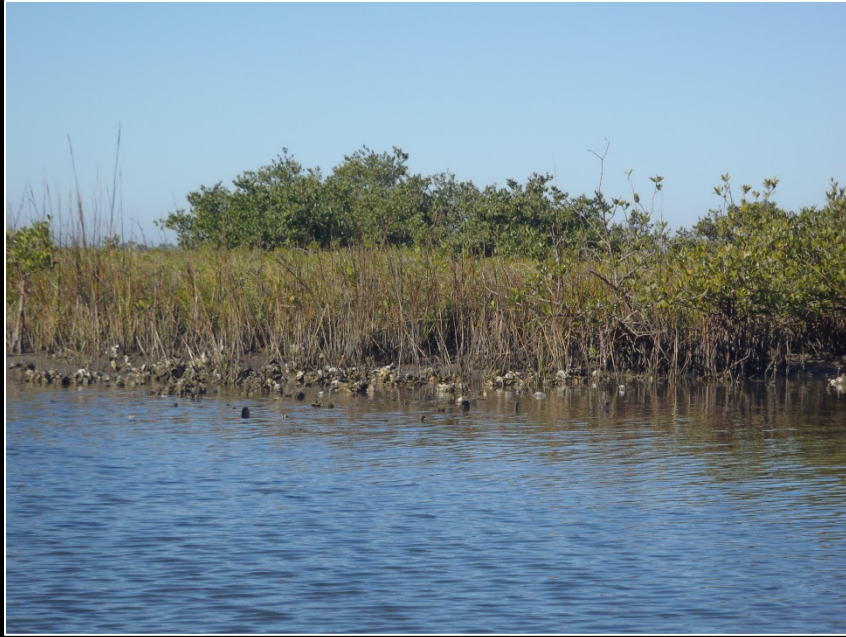
Natural shorelines have 3 layers of defense against erosion

- Upper Intertidal= mangroves
- Middle Intertidal= smooth cordgrass
- Lower Intertidal= oysters

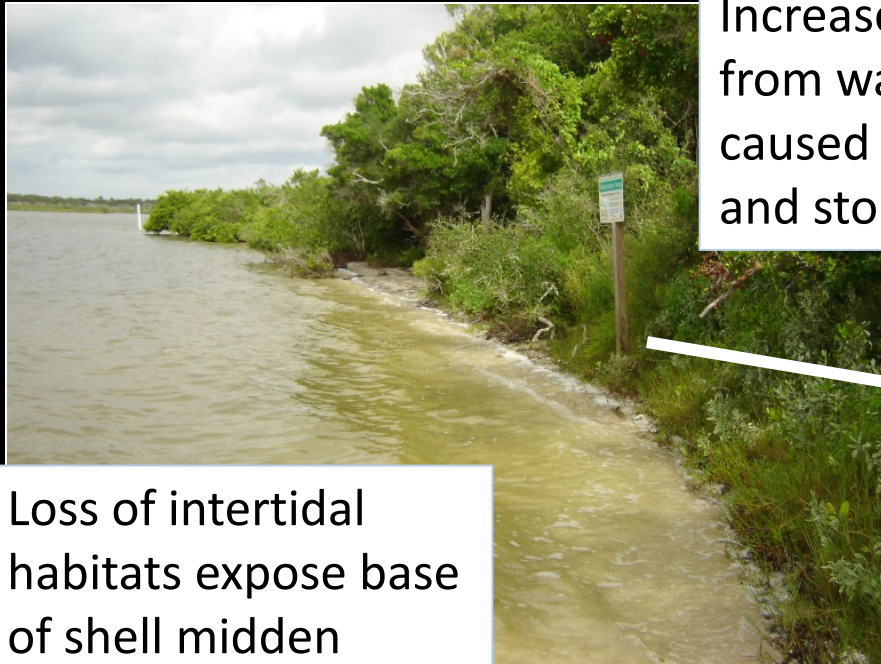
Loss of intertidal habitats expose base of shell midden

Increased erosion from wave action caused by boats and storms

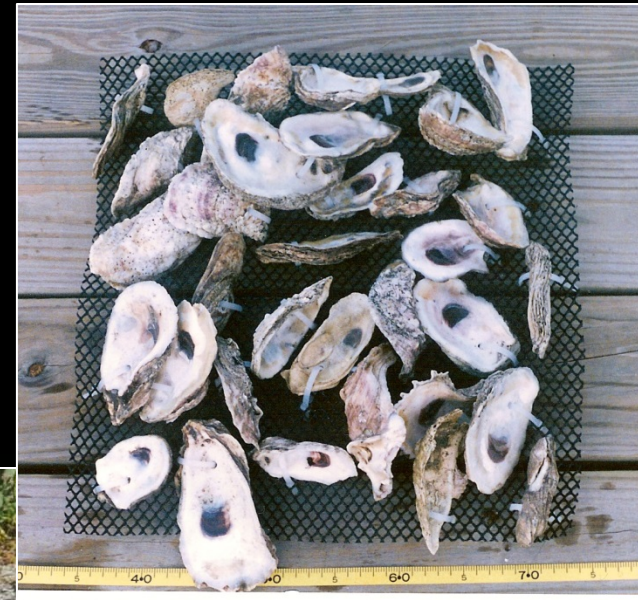
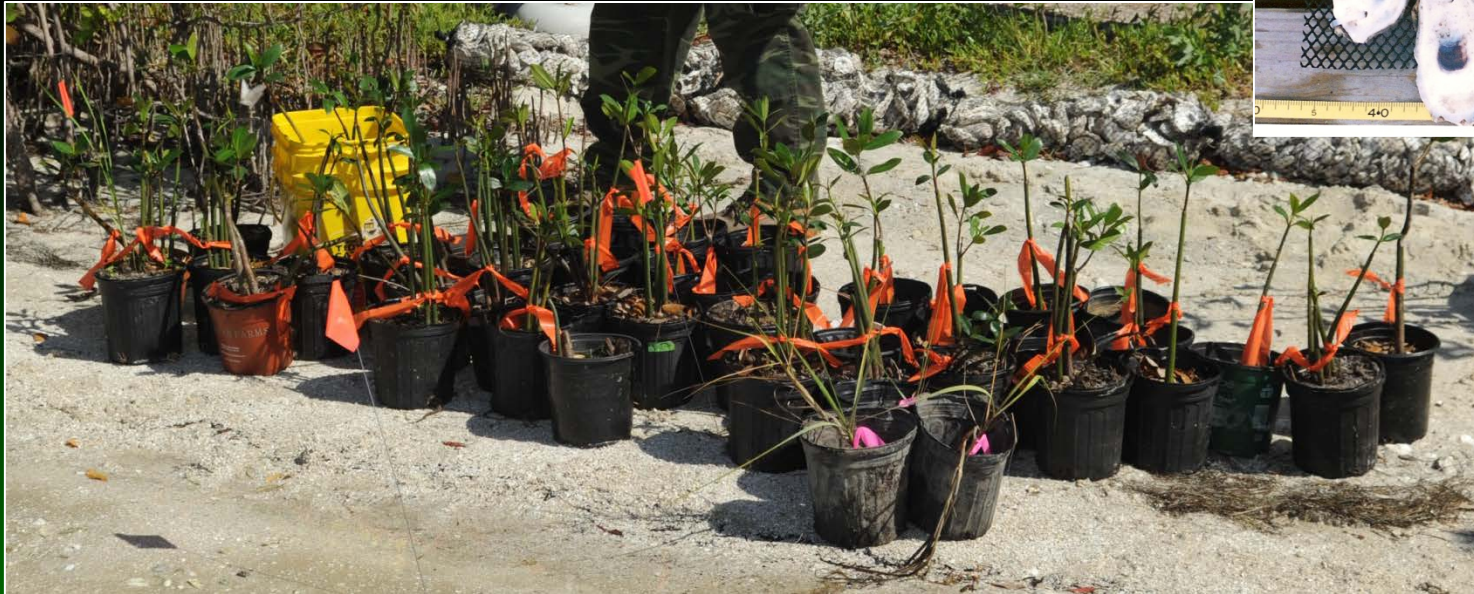
Living Shoreline Stabilization at Turtle Mound

- Red and Black Mangroves
 - 1 yr old seedlings
- Smooth Cordgrass
 - 1 yr old transplants

- Oyster Mats

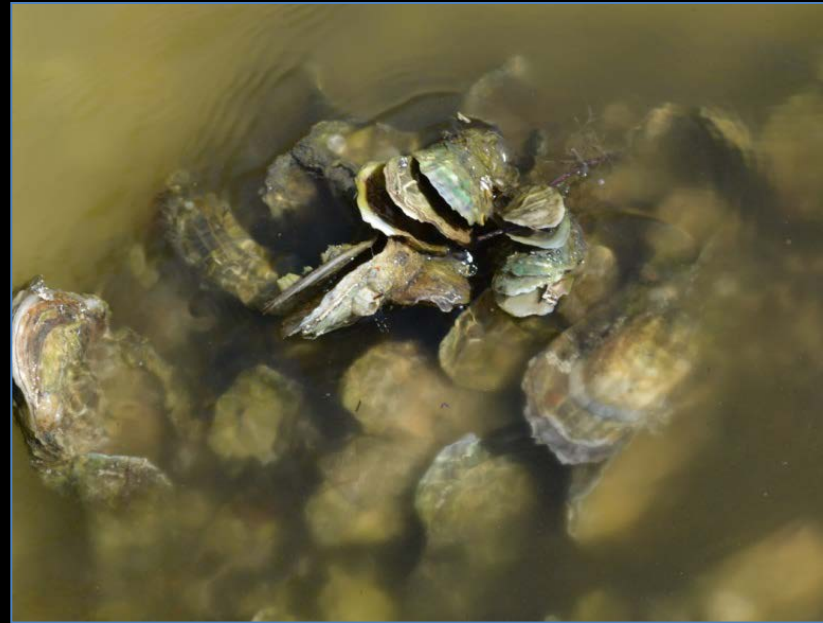
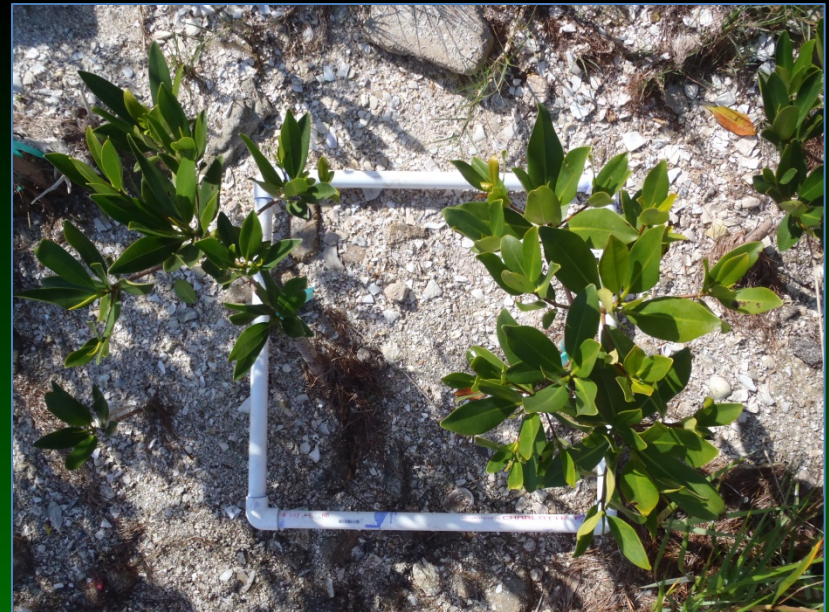
Post-Stabilization Monitoring

- Erosion
 - Restored
 - Unrestored (control)
- Oyster Recruitment
 - 30 mats
- Plant Survival and Percent Cover
 - 2 rows of 30- 0.25 m² quadrats
 - Point-Intercept Method

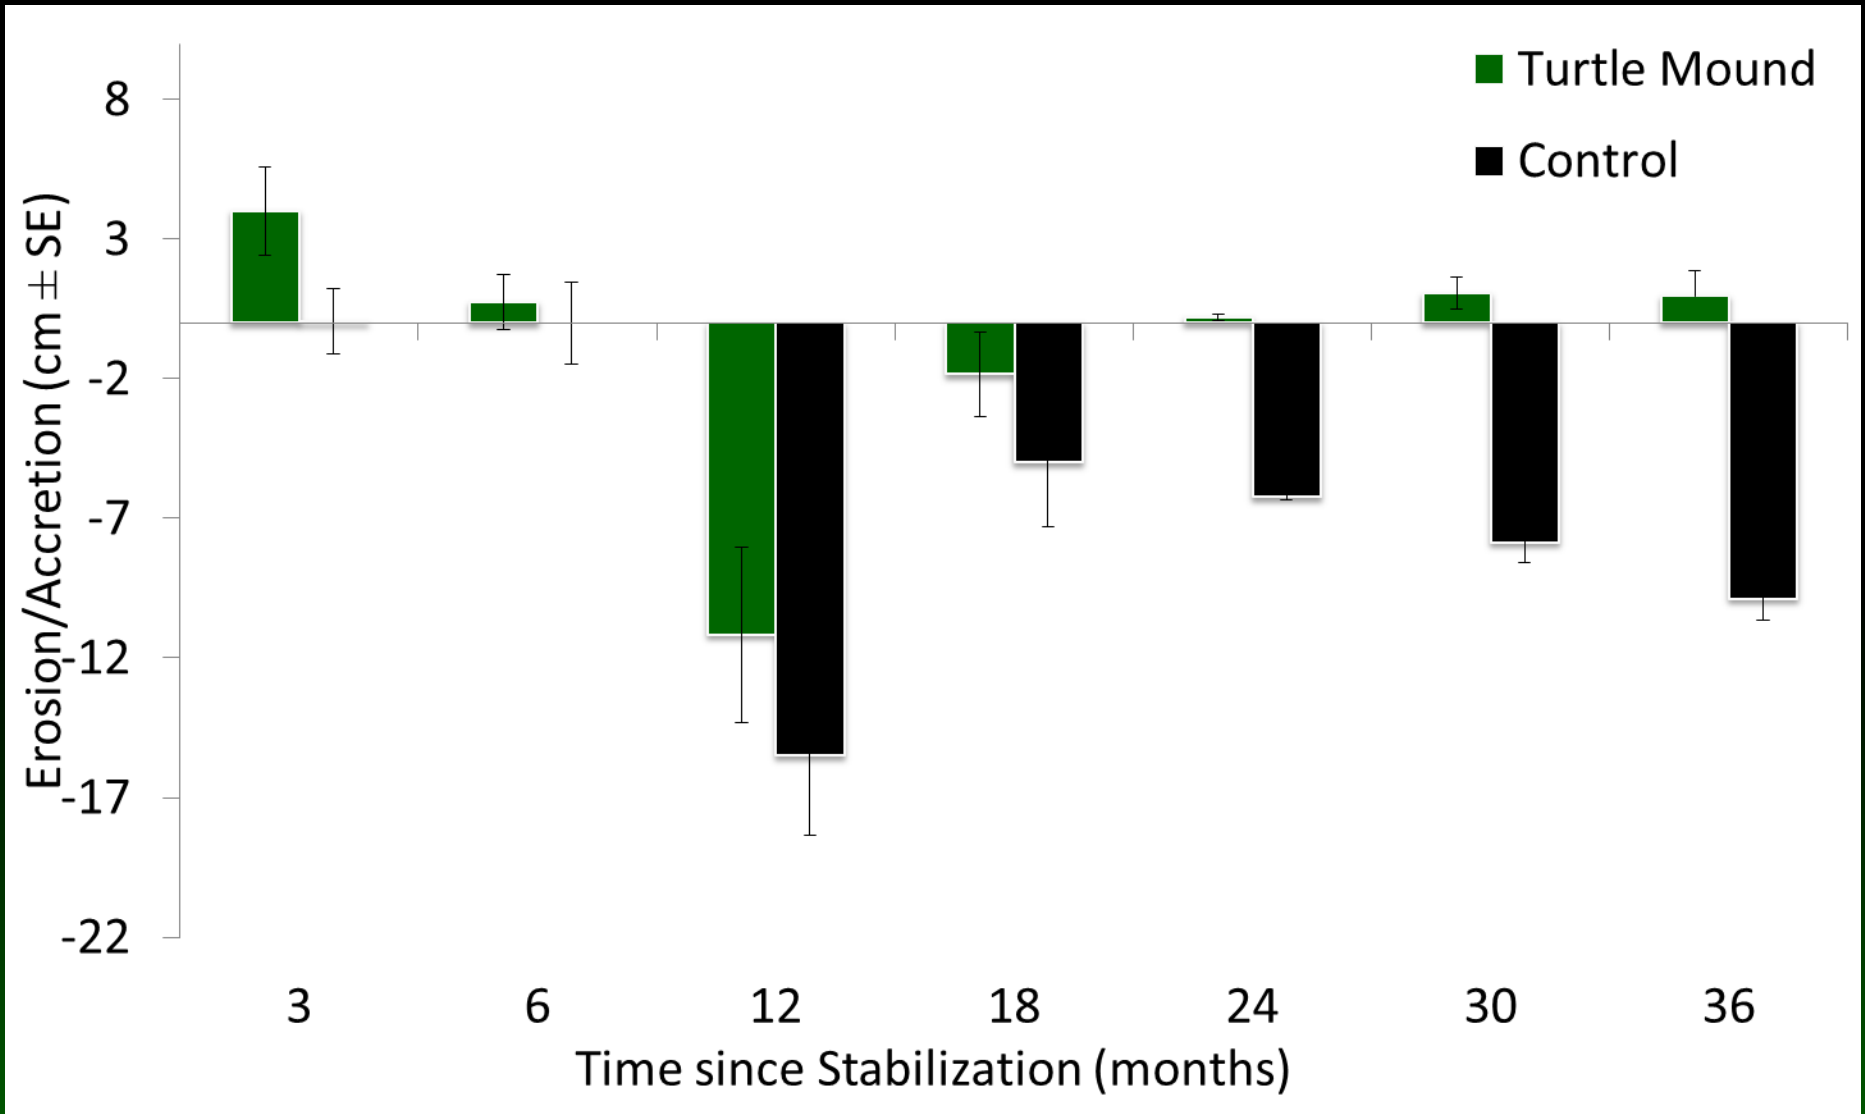
Post-Stabilization Monitoring

Average Mean Sea Level Rise = 0.24 cm/yr

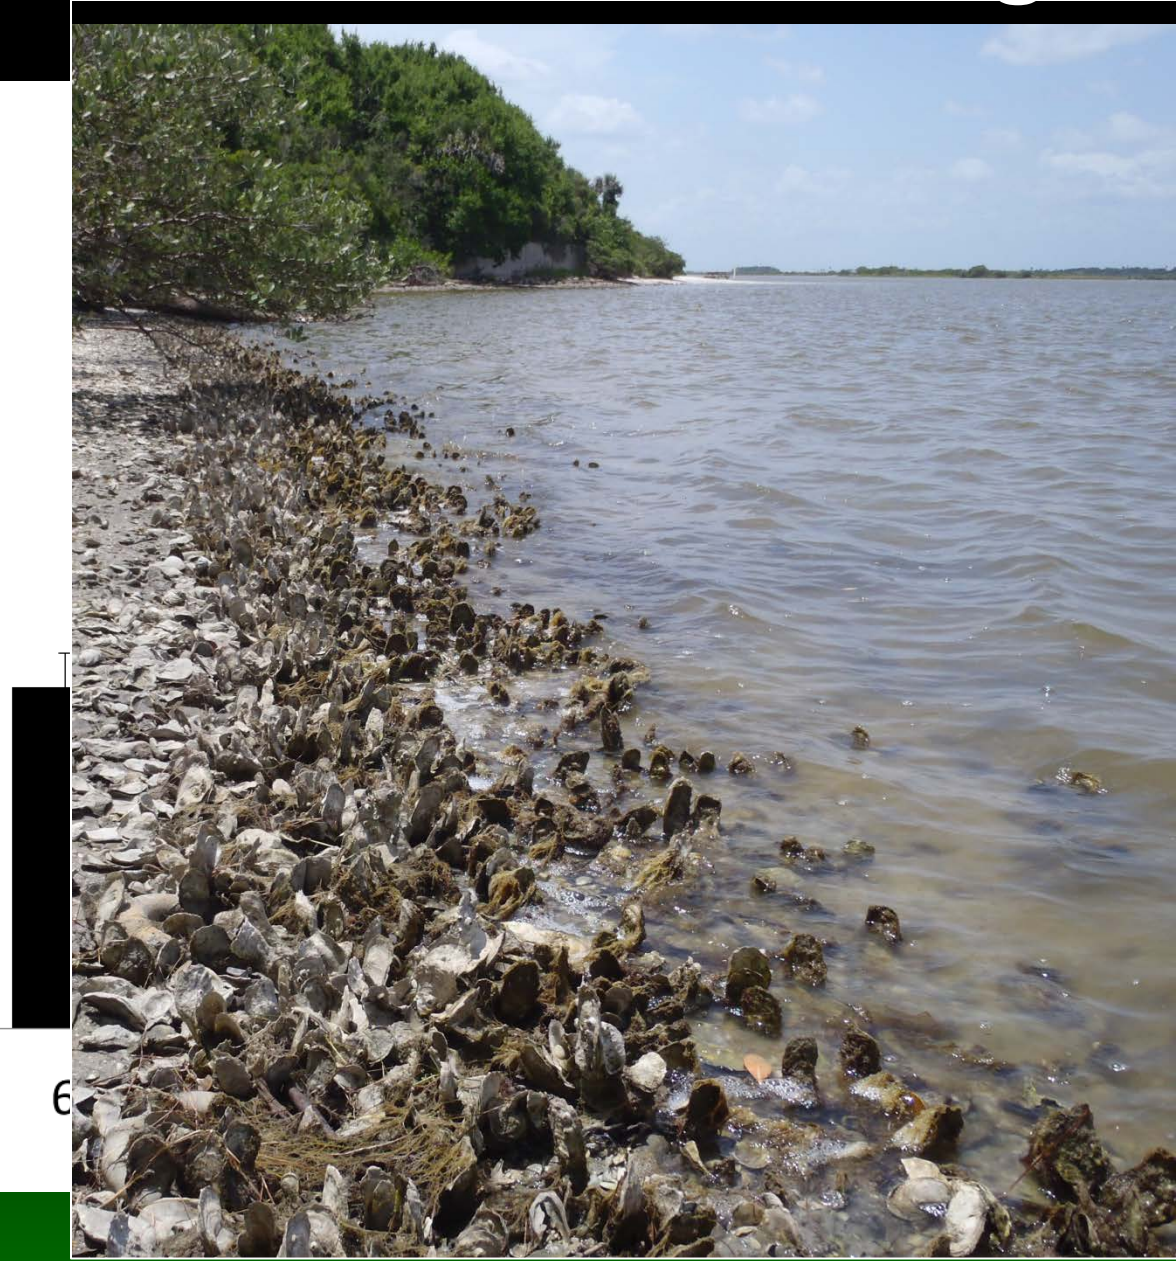
Post-Stabilization Monitoring

Mean # Oysters per m² (\pm SE)

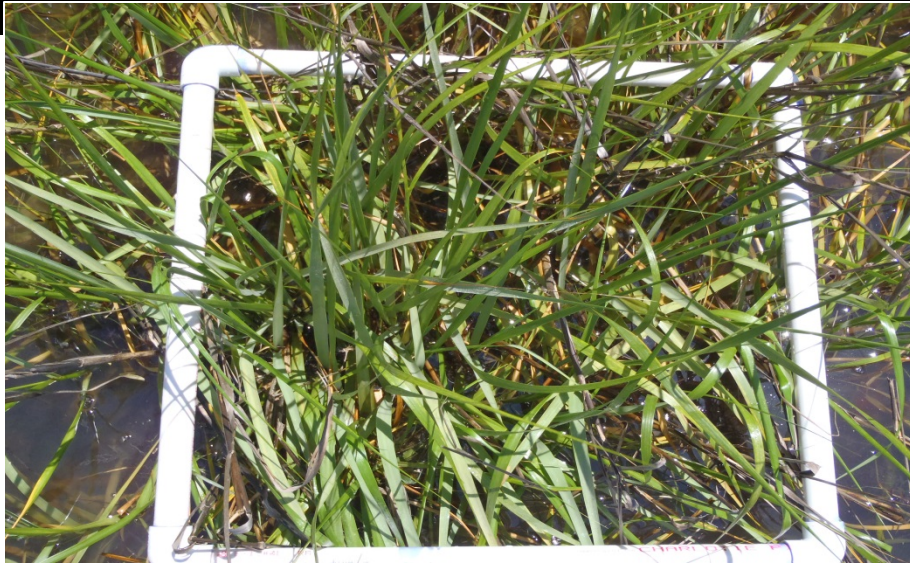
Post-Stabilization Monitoring

- Cordgrass Zone
- Mangrove Zone

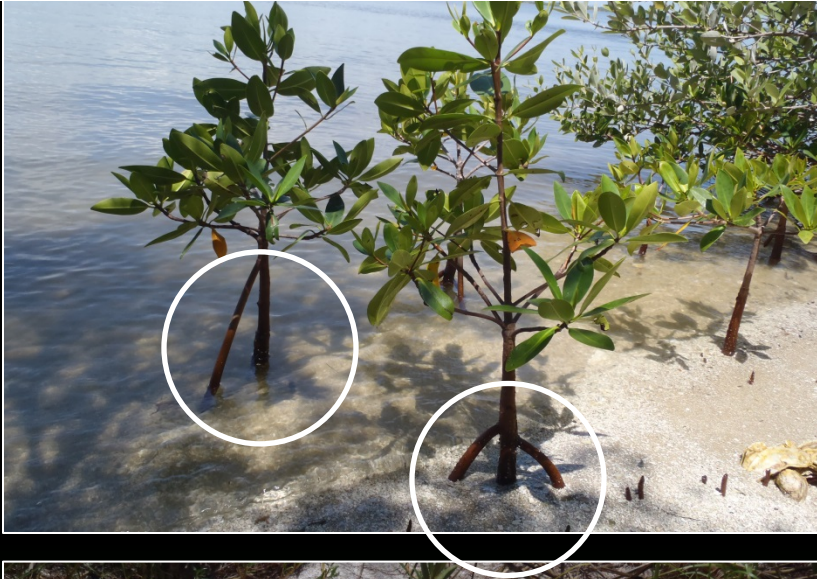
Above-Ground Root Structures

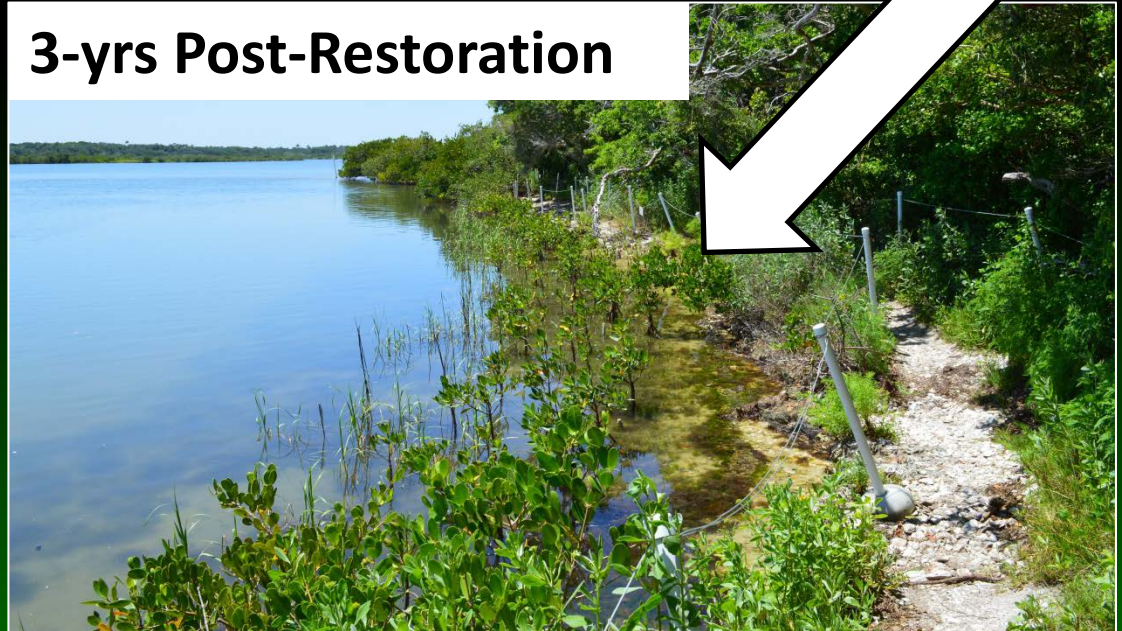
3-yrs Post-Restoration

- Accretion of sediment
- Increased intertidal habitat

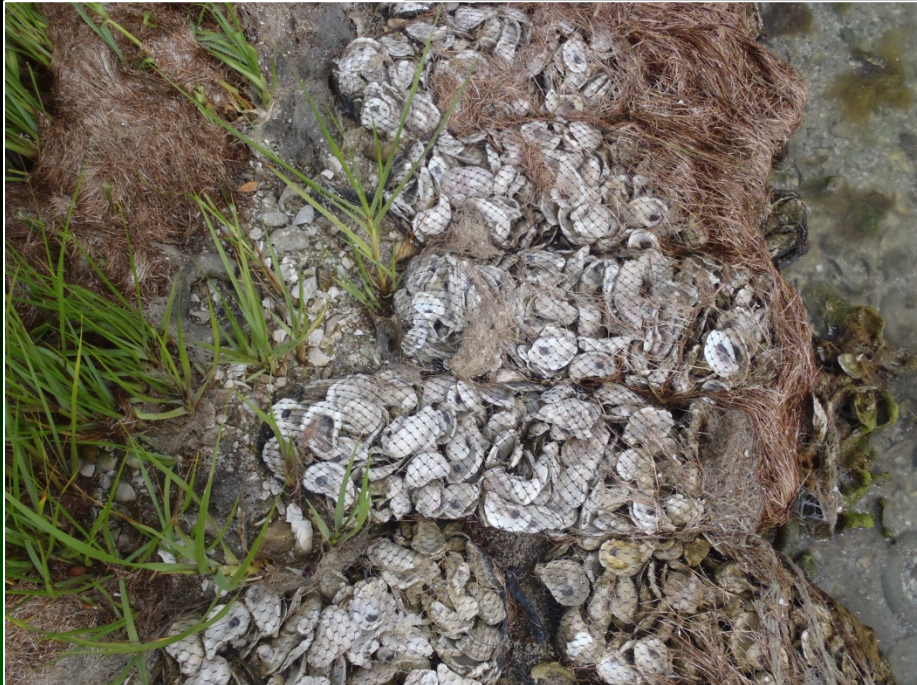
Shell Bags

- 2 shorelines were stabilized this summer
- Tests of alternate methods
