Public Service Company of Colorado (PSCo), an Xcel Energy company, owns and operates under a license issued by the Federal Energy Regulatory Commission (FERC) the Cabin Creek Pumped Storage Hydroelectric Project (FERC No. 2351). As part of the relicensing studies, HDR conducted a functional assessment of all ecologically significant riparian and wetland areas to determine the condition of site wetland functions and characteristics. The Project is located within the Arapaho National Forest and occupies a total of 268 acres of National Forest lands. The site is located on South Clear Creek and its tributary, Cabin Creek, in Clear Creek County, Colorado, USA.

# Functionality of Alpine Wetland Habitats Using the Functional Assessment of Colorado Wetlands Method (FACWet) at a Pumped Storage Hydroelectric Facility in the Rocky Mountains of Colorado

Erin Page, HDR Engineering - Bellingham, Washington

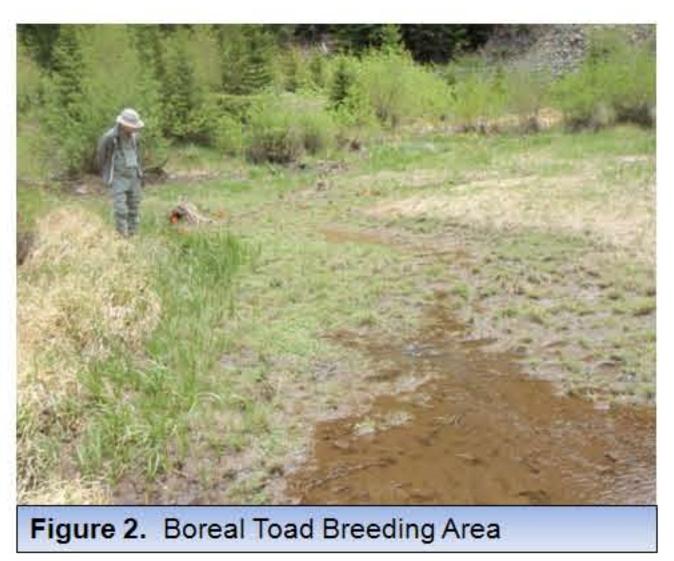
Changes to Site 4 were documented in 2011. High spring runoff caused downcutting erosion and loss of woody debris at the outlet of the site damaged vulnerable, remnant beaver dams (Figures 1, 2 and 4).

To restore suitable boreal toad breeding and rearing conditions, PSCo and HDR are repairing the remnant beaver dam that shelters the breeding pool from damaging flows and aquatic predators. Currently, a stop-gap repair will consist of patching the hole in the remnant beaver dam and reinforcing the immediately adjacent structure (Figure 5). The dam patch will be comprised of suitably sized woody debris collected from the trash rack, sandbags and stockpiled soil from within the Project Boundary. PSCo will also evaluate the overflow spill outlet, and will design the repaired dam to hold water in the pool, optimizing the size/depth of the pool for breeding. Without repair of the remnant beaver dam, it is likely that Site 4 will be lost as boreal toad breeding habitat, the remnant beaver dam will continue to deteriorate, and other functional values of the wetland will degrade. Although no measure can guarantee successful boreal toad breeding and rearing, PSCo anticipates that this stop-gap measure will be sufficient to permit boreal toad breeding in 2012 and maintain the population until a more robust enhancement is implemented.
