Restoration of Sand Mined Wetlands in the Wild Duck Lake Natural Reserve, Beijing: Approaches and Evaluation

Manyin Zhang, Lijuan Cui, Wang Yifei, etc. Institute of Wetland Research, CAF

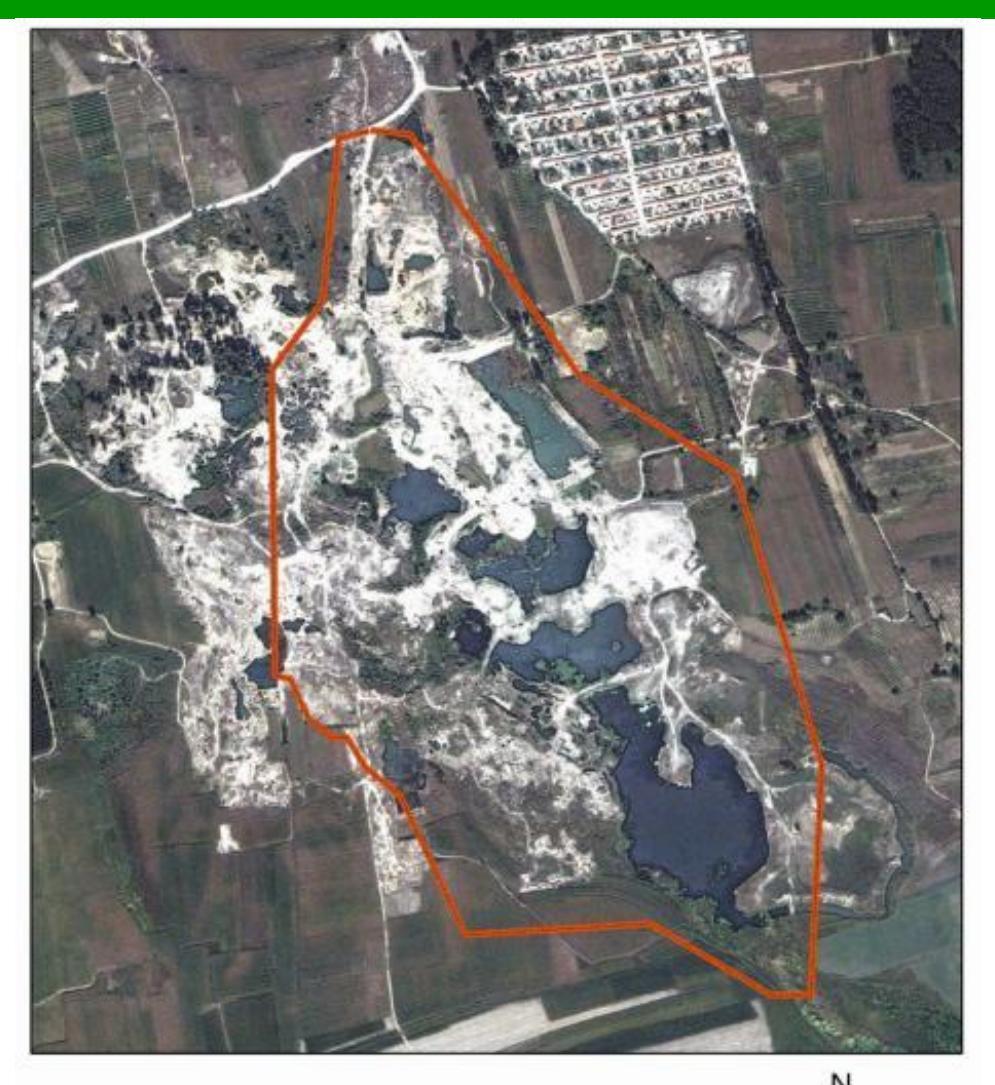
the project area(Google Earth Sep. 2007)

10 kilometers to the west of Yanqing County

Inside Wild Duck Lake Nature Reserve

eabout 56 ha

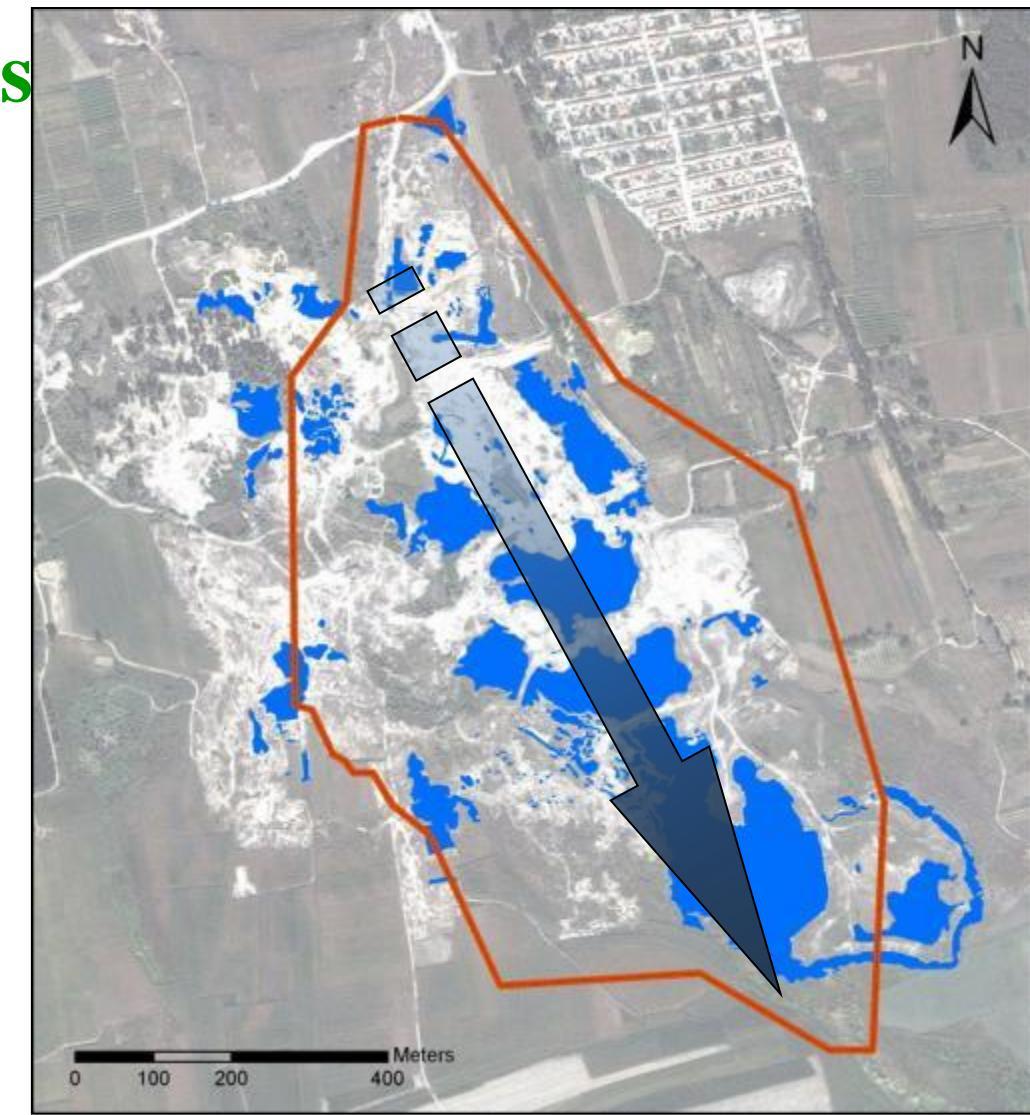
Hydrological conditions

- a group of separated water bodies of different sizes,
- water supply is mainly from natural precipitation and underground seepage.

Low-lying area

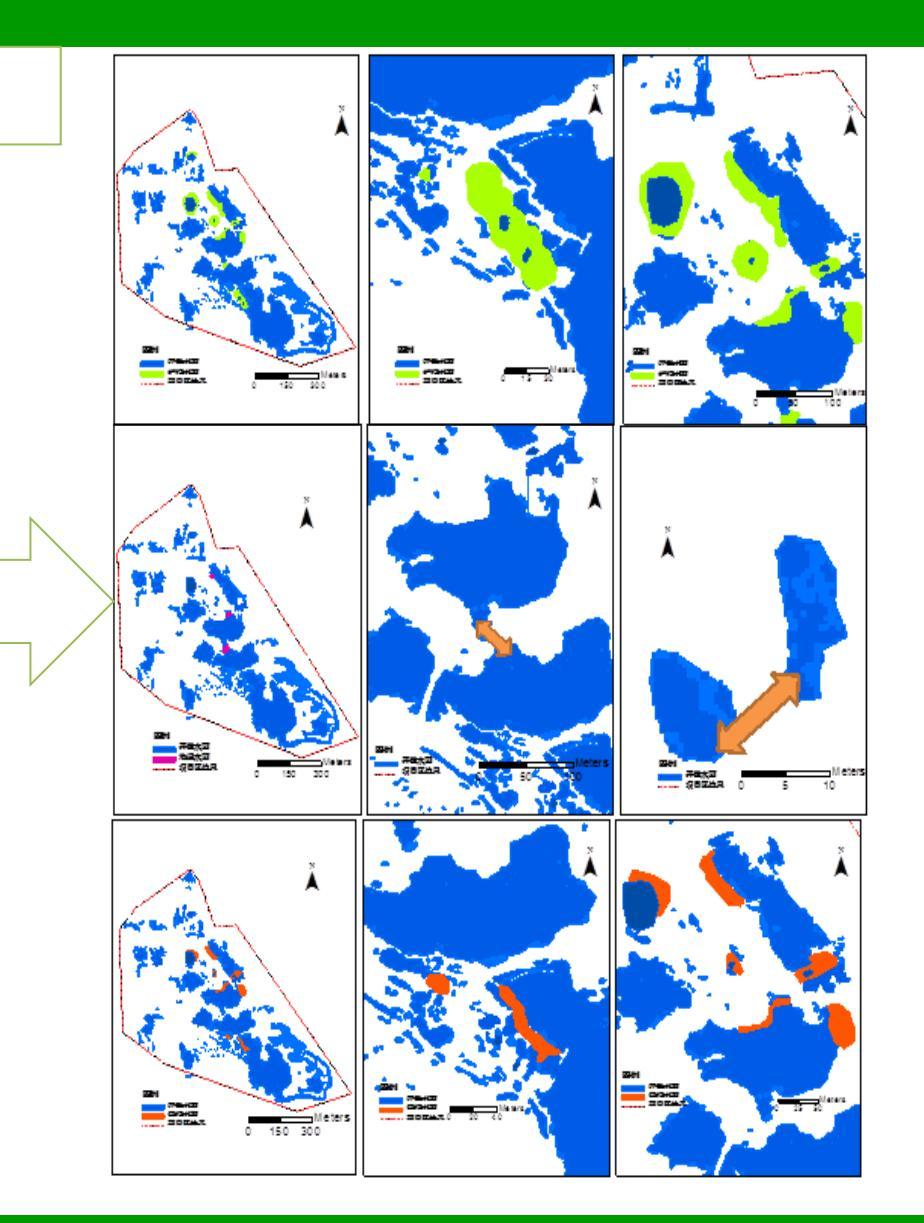
Restored hydrological regimes

Small water body enlarging
Small water body connection
Partial deep digging
Partial impede water flow

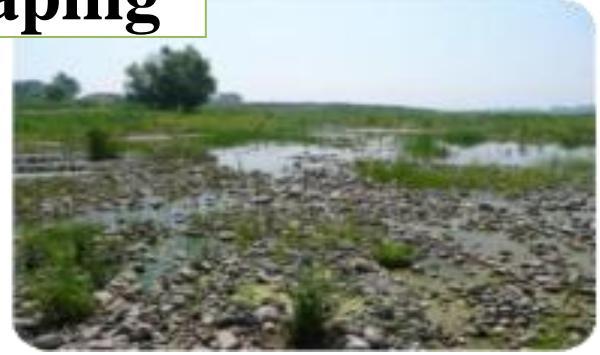
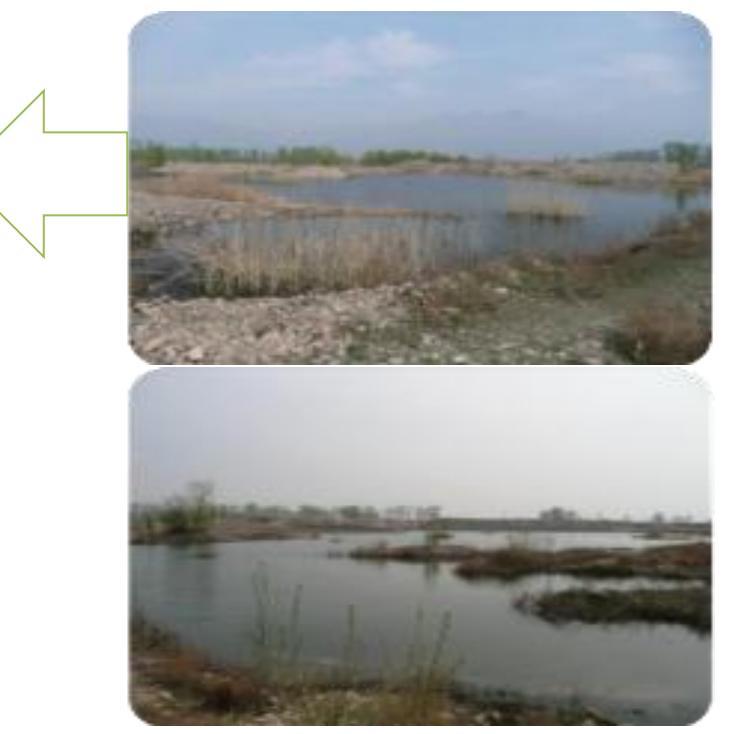
Micro-topography modeling and reshaping

Shoal Construction

Small water surface regulation

Habitat island creation

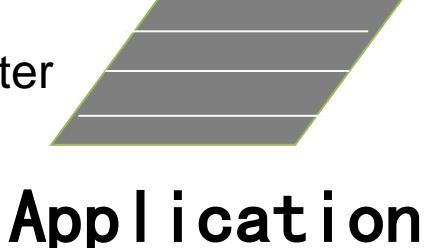
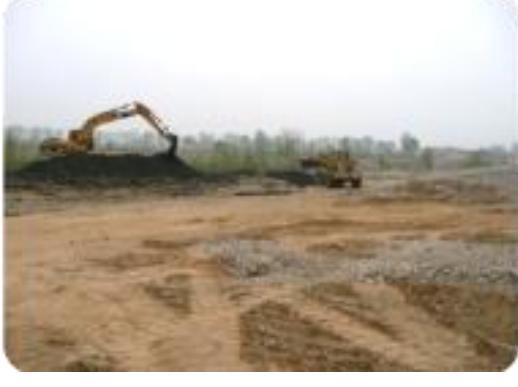
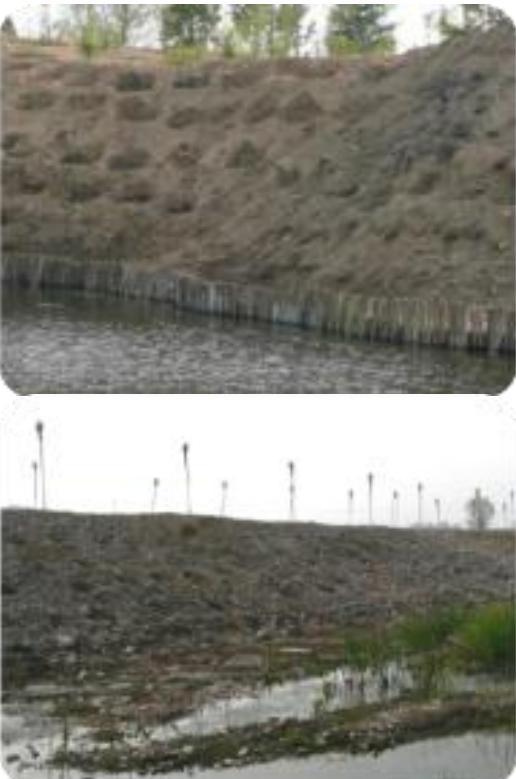
Soil organic matter recovery

Layered backfill

Plant hole backfill

Plant trough backfill

volume of earthwork: 10,000 Cubic meter loam soil

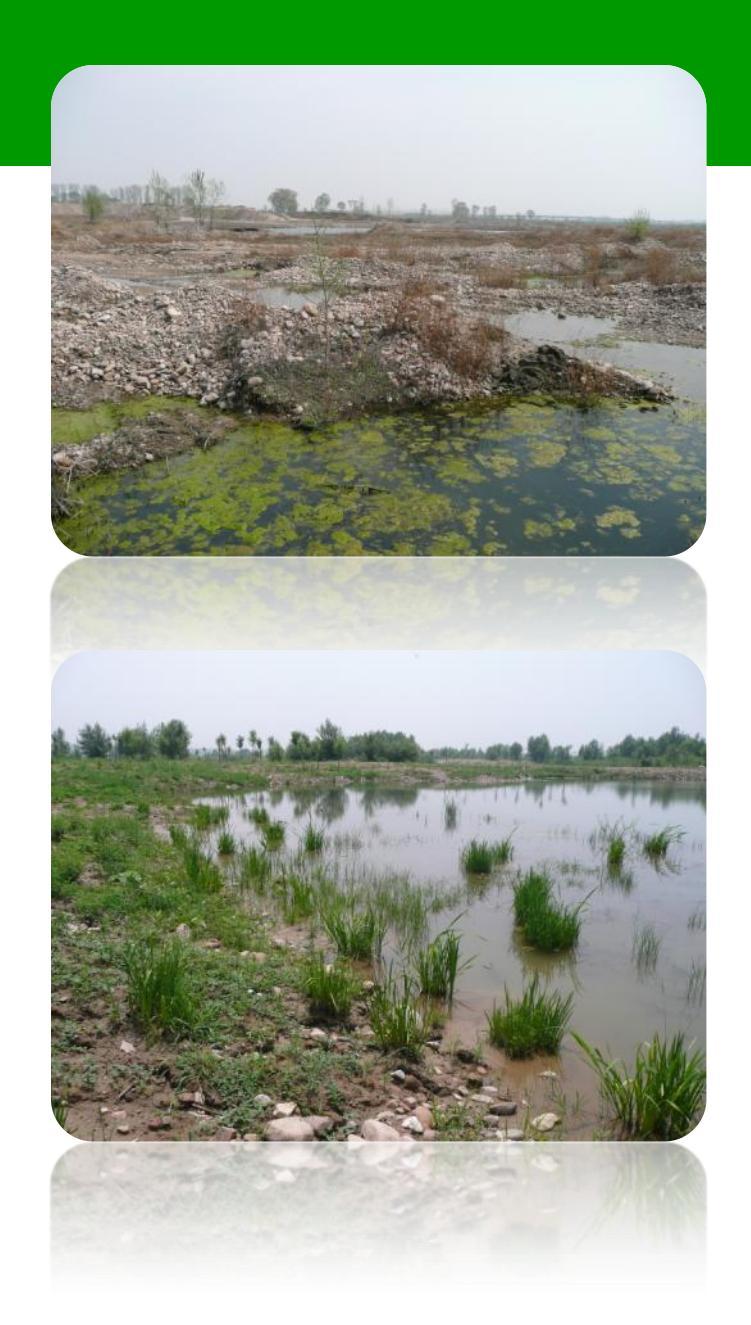
Vegetation planting

- Small water surface vegetation planting
 Large water surface vegetation planting
 vegetation exposed from beach in normal water level
- vegetation planting below
 Normal water level

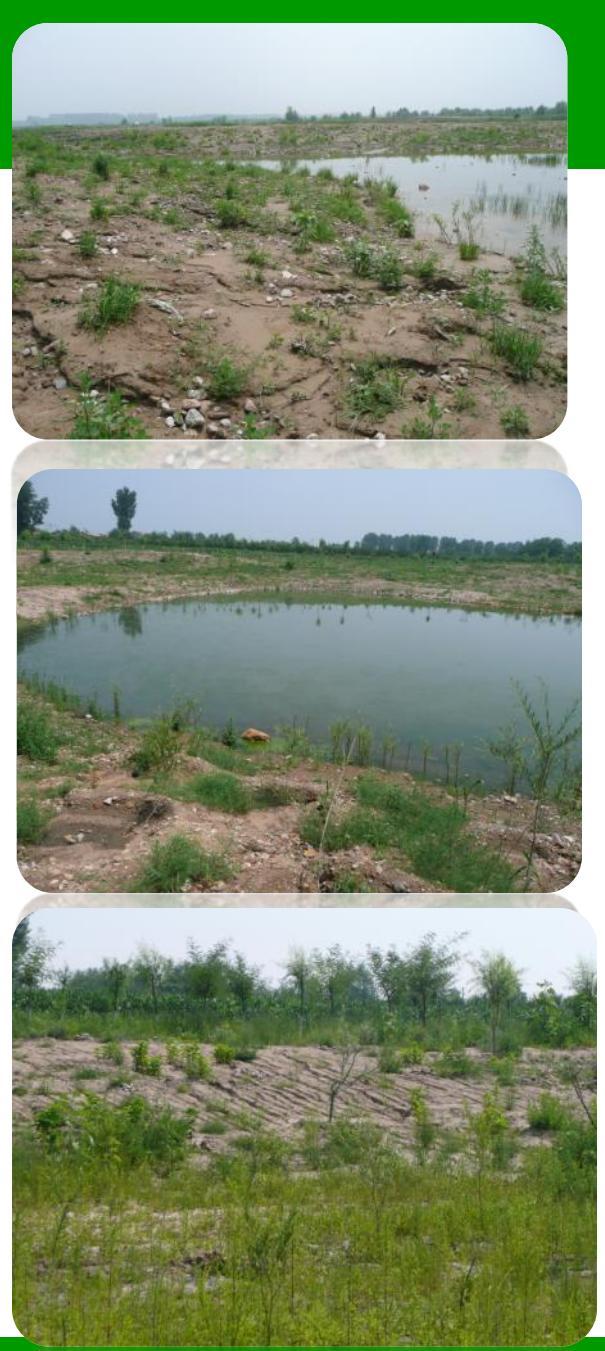
Vegetation planting

Waterfront vegetation planting
Buffer zone vegetation planting
slope protection vegetation planting

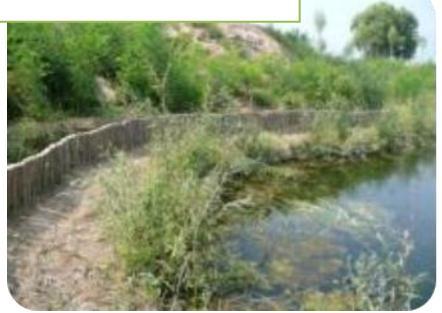
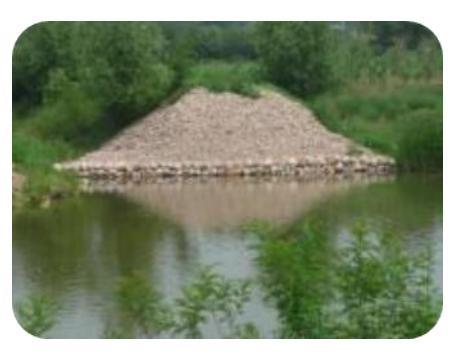
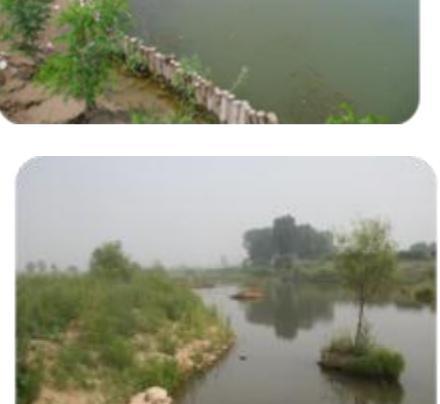
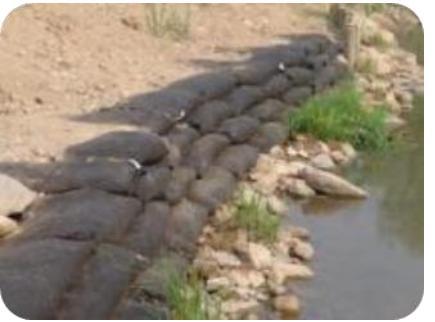
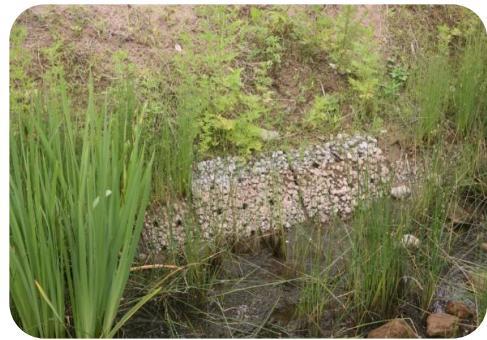
Construction of ecological revetments

- Timber pile slope protection
 Willow timber pile
- Rock slope protectionDifference size
- Eco-bags slope protection
 Long-life(anti ultraviolet rays)
- Ecological concrete slope protection
